# **Tire Induced Surface Cracking**

due to Extreme Wheel Loads

Fer Mooren, Marc Stet, Piet Hopman 06 August 2014

Presented at the 2014 FAA Worldwide Airport Technology Transfer Conference August 5-7, 2014

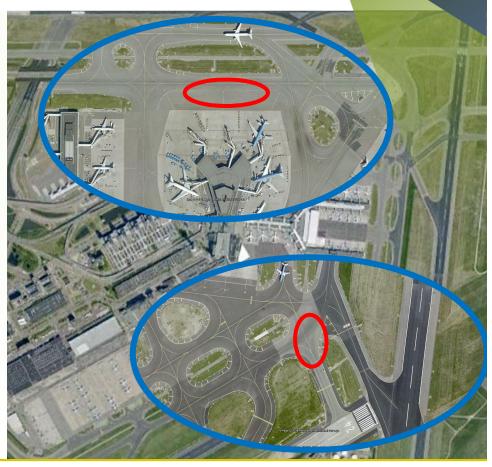
#### **Recurring Surface Distresses**

- Entry TWY A8 towards RWY 24
- Circulation TWY A at wide-body F-pier
- Both locations subject to high shear
- Multiple resurfacings executed

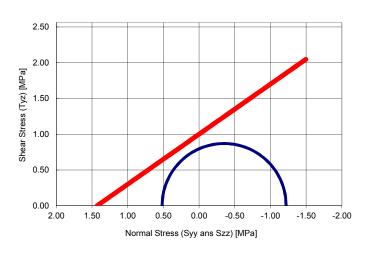
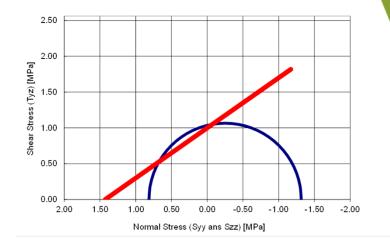
# Failure as per Mohr-Coulomb

# Factor of Structural Robustness F<sub>SR</sub>

$$F_{SR} = c \times \cos(\phi) \times \left(\sqrt{\left(\frac{1}{2}S_{zz} - \frac{1}{2}S_{yy}\right)^2 + T_{yz}^2} + \frac{1}{2}\left(S_{zz} + S_{yy}\right)\sin(\phi)\right)^{-1}$$

Fsr > 1
No Failure

Fsr < 1 Failure

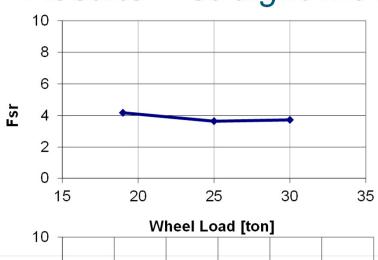
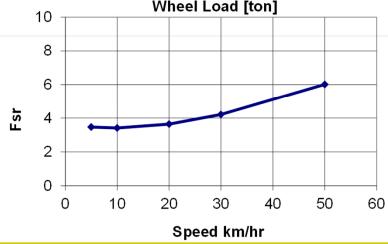
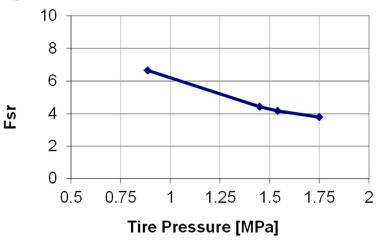
# Results - Straight Moving Loads

No risk of failure with straight moving loads, uniform stress and c = 1 MPa

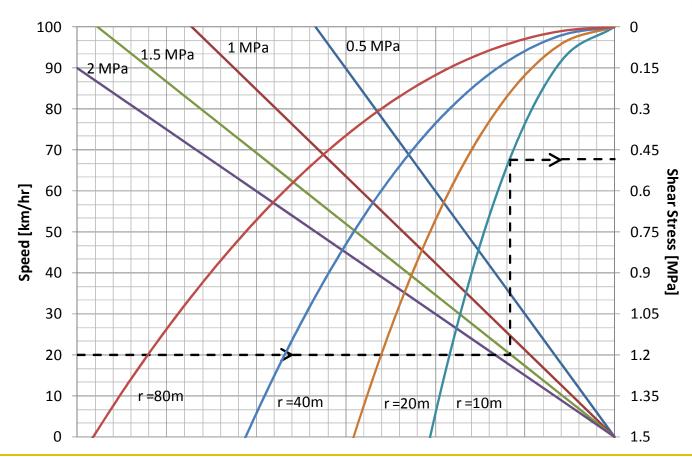
# Shear Stress Nomogram

- Standard taxiway curve 55 m centreline radius
- Wide-body mean gear (B777) = 35 m, 1.54 MPa tire pressure
- Horizontal shear by:
  - $\sigma$  = tire pressure [MPa]
  - v = speed [km/hr]
  - R = curve radius [m]
  - τ = shear stress [MPa]

Speed	Horizontal shear	G-force
20 km/hr	0.14 MPa	0.09g
30 km/hr	0.31 MPa	0.20g
50 km/hr	0.85 MPa	0.56g

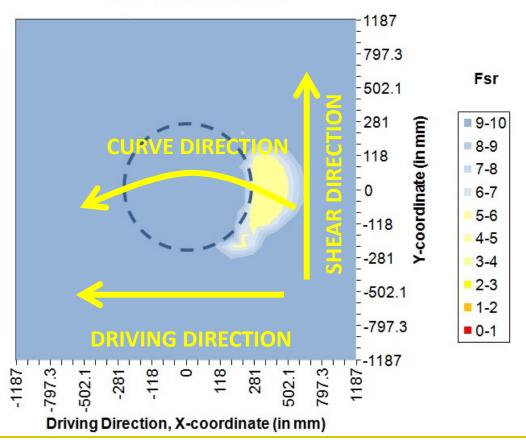
B777 r=35m v=20kmh

#### Results – Loads in Curves

- Tire Pressure = 1.54 MPa
- R = 35 m
- Speed = 20 km/hr

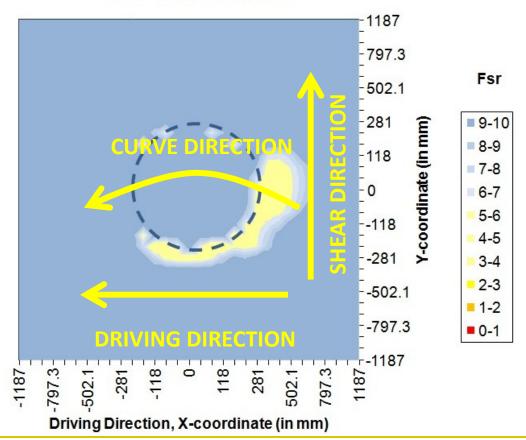
B777 r=35m v=30kmh

#### Results – Loads in Curves

- Tire Pressure = 1.54 MPa
- R = 35 m
- Speed = 30 km/hr

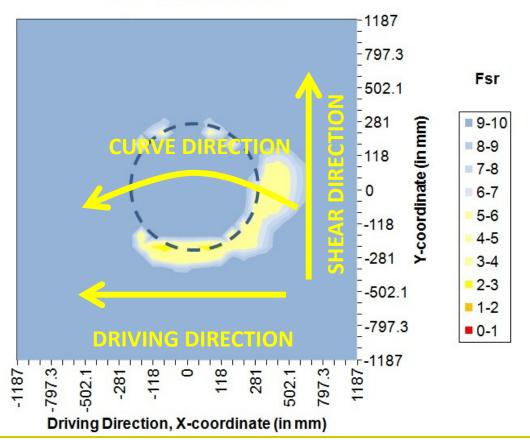
B777 r=35m v=34kmh

#### Results – Loads in Curves

- Tire Pressure = 1.54 MPa
- R = 35 m
- Speed = 34 km/hr

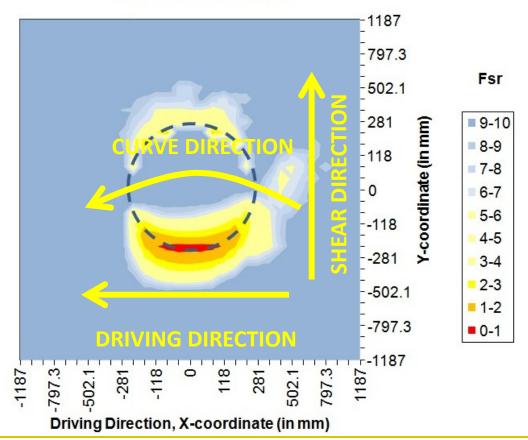
B777 r=35m v=50kmh

#### Results – Loads in Curves

- Tire Pressure = 1.54 MPa
- R = 35 m
- Speed = 50 km/hr

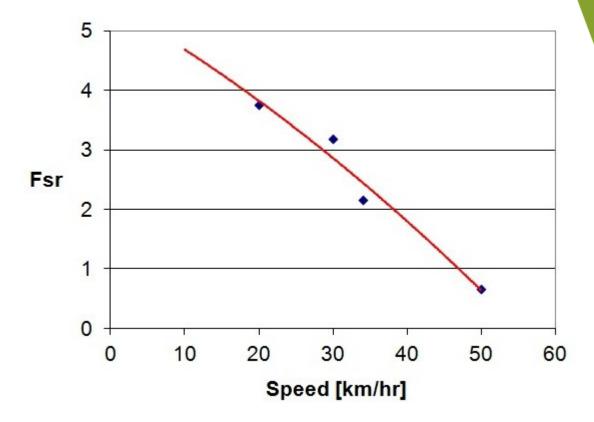
#### Results – Loads in Curves

- Tire Pressure = 1.54 MPa
- R = 35 m

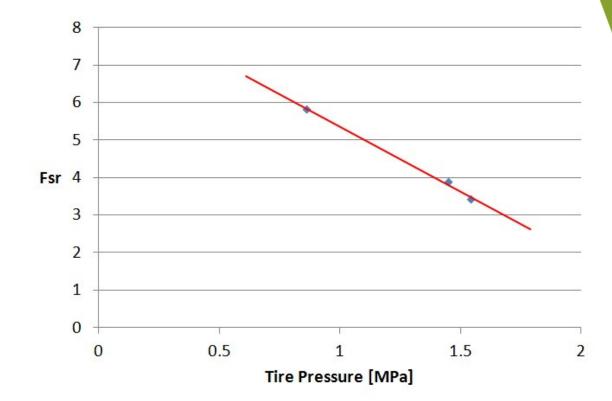
### Results - Normal Pushback

- = v = 10 km/hr
- R = 10 m

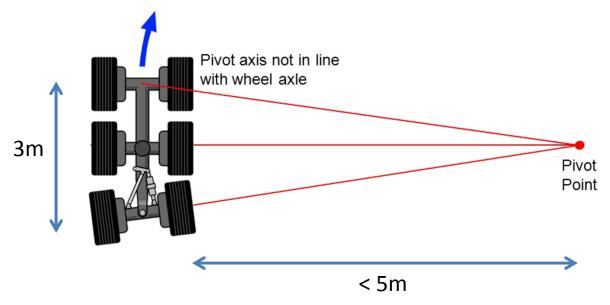
### Results - Lateral Wheel Slip

- Normal push-back at low speed and r > 10 m → No risk
- Extreme push-back, sharp steering angle → high risk with (tri)tandem axles due to wheel slip

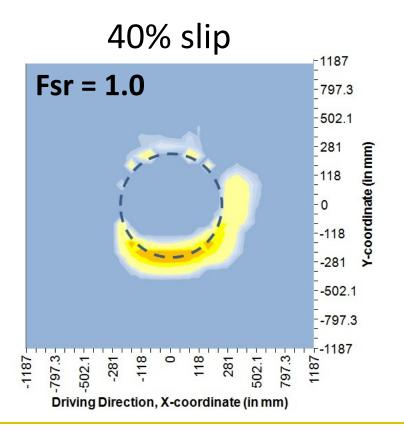
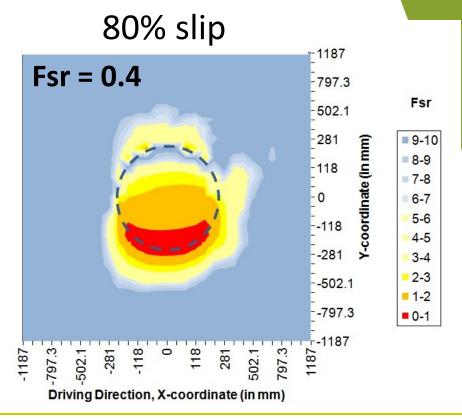
## Results - Lateral Wheel Slip

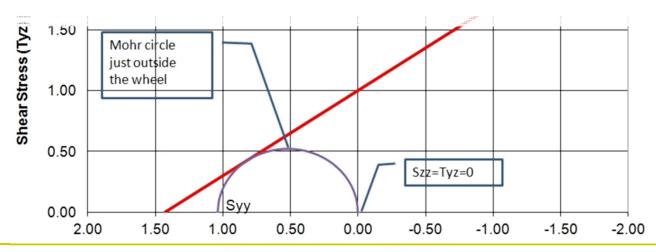
- Gerrard and Harrison [1970]; Analytical model for stresses in uniform halfspace due to circular wheel load, also at z = 0 and y = r.
- Take stress condition just outside wheel;  $σ_{zz} = τ_{yz} = 0$
- Combine with Fsr failure model and take Fsr = 1

Normal Stress (Syy ans Szz) [MPa]

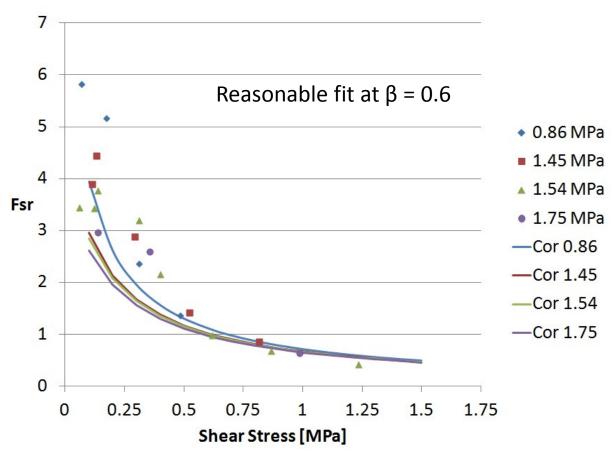
# **Analytical Model**

### Fit with Numerical Results

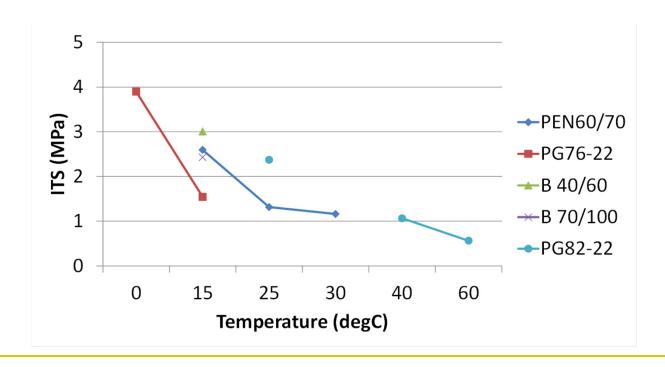
# Proportional to ITS and Sensitive to Temperature

Mix Cohesion = 1.75 x ITS (Christensen, Bonaquist)
